Simon Pryce, Arboricultural Consultant

Report

Site: BAM Estate Gardens, London, NW3

Reference: 06/043

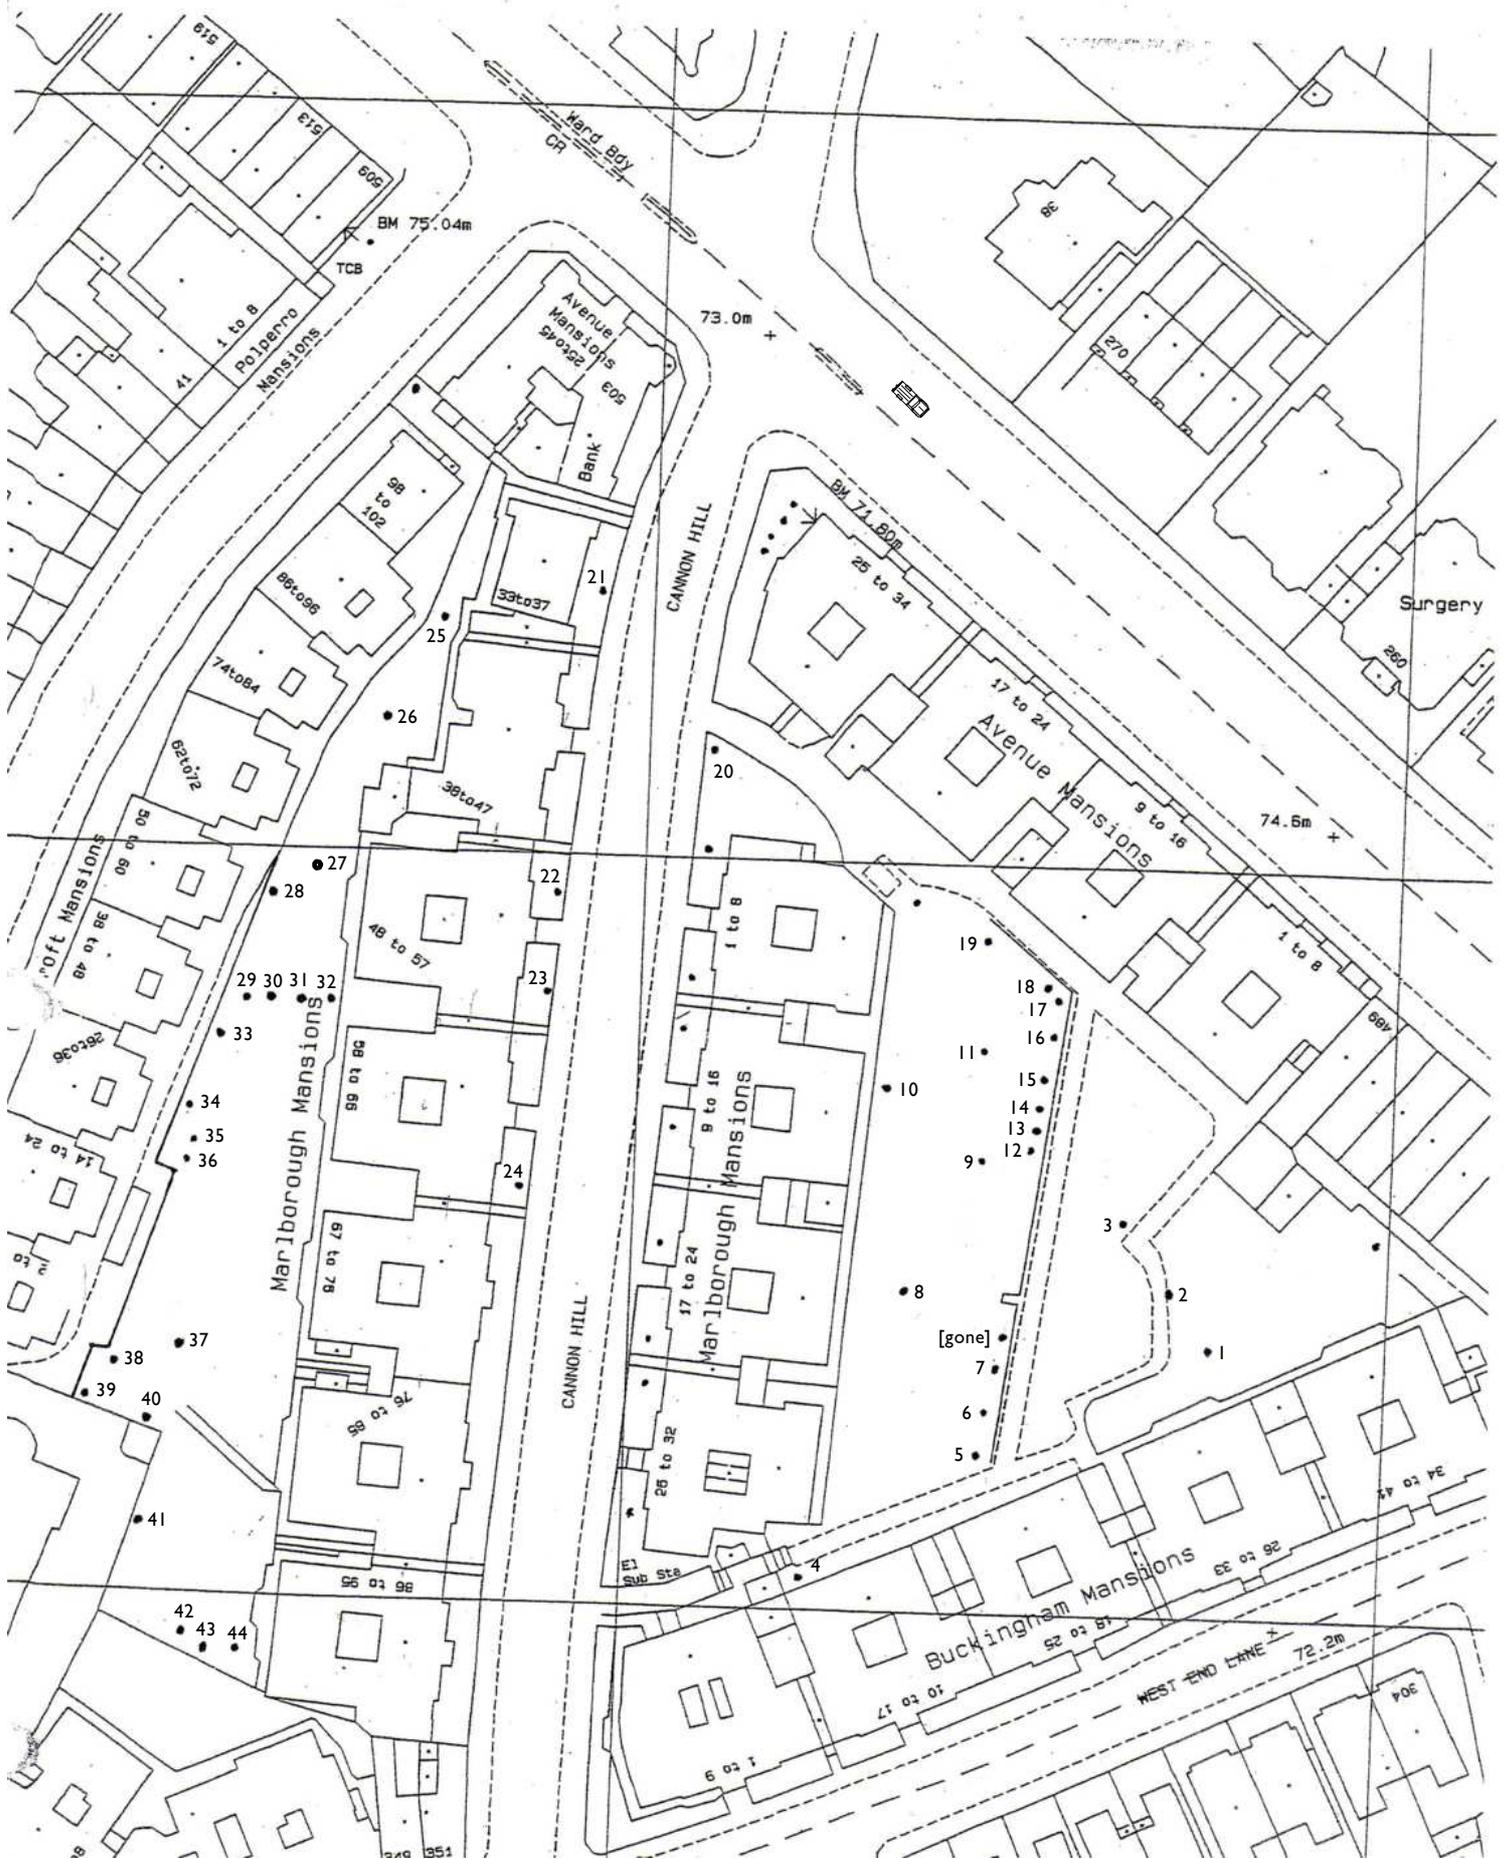
- 1.3 Some general comments have been made below and the trees are listed individually in the schedule forming the second part of this report, with recommendations for suitable work. They are shown on the attached site plan, which is based on an annotated OS extract supplied by the estate.
